UNITED STATES ENVIRONMENTAL PROTECTION AGENCY

INSTALLATION NAME: Arcelor Mittal Burns Harbor, LLC

DATE OF RCRA INSPECTION: June 13, 14, 15, 20, 27 - 30, 2011

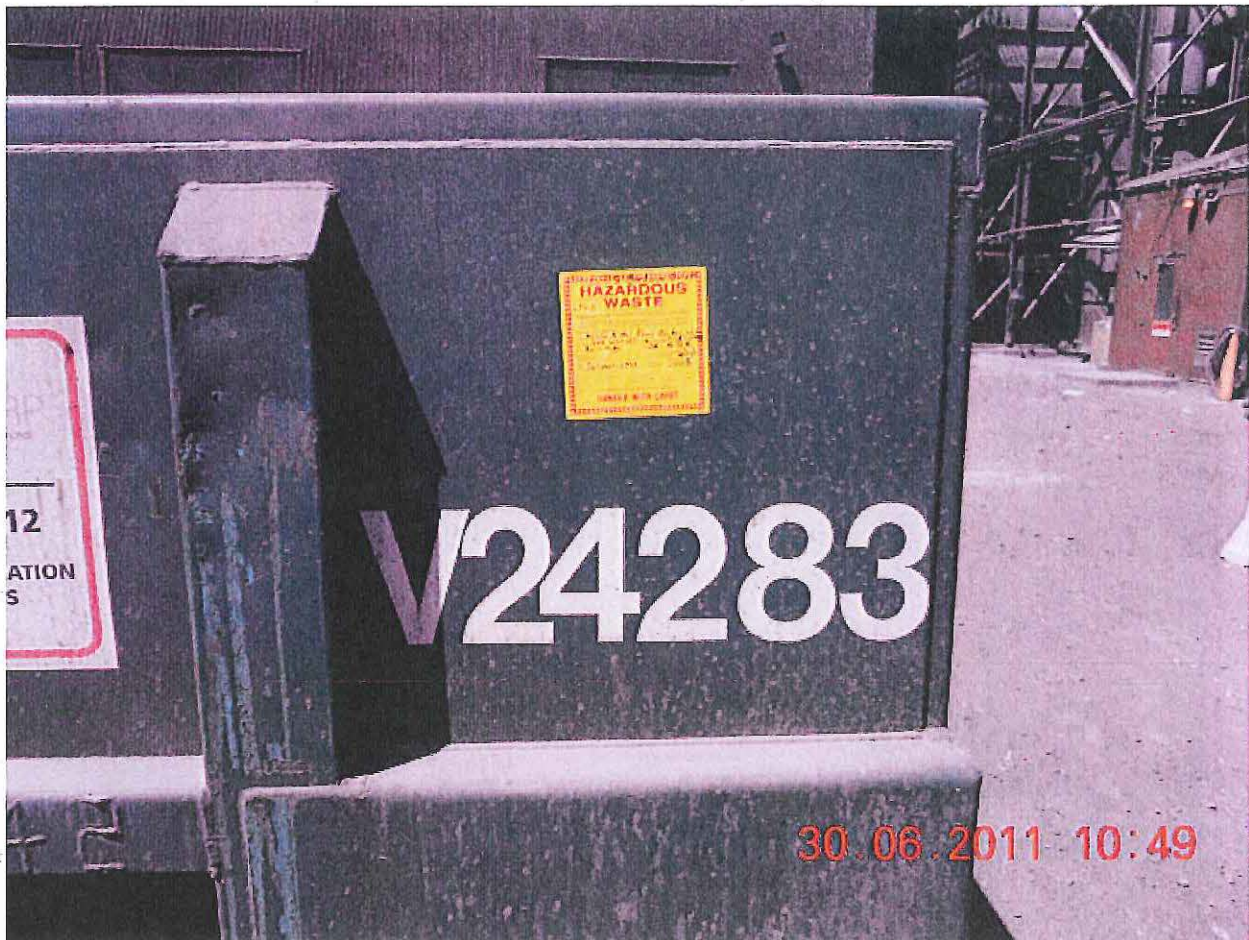
- Inspector Smith observed and photographed that an employee from AM had removed much of the suspected hazardous waste dust as he collected samples for analysis. The photograph clearly shows the blown gasket (Photograph 93).
- Inspector Smith observed and photographed the hazardous waste sticker on the roll-off box that released the suspected hazardous waste dust (photograph 94).
- Inspector Smith observed and photographed the opposite end of the roll off box with the serial number V24283 that released the potential hazardous waste dust. The roll off box had a hazardous waste sticker that was photographed in photograph 94 (photograph 95).

Facility: Arcelor Mittal, IND003913423
Location: 250 West US Highway 12, Burns Harbor, Indiana
Date: June 30, 2011, 10:49 a.m.
Photographer: Robert Dean Smith, LPG
Camera: Nikon Coolpix, 12.0 megapixels
Description: Photograph 95: Identification of the vacuum roll off box V24283 which had a blown gasket which caused a release of hazardous waste LTS dust to the environment. This vacuum roll-off box is located in the furnace area of the plant. This area is 30 degrees off of "plant north". The orientation is rotated 30 degrees to the west. Plant north is close to true north . The orientation of the vacuum roll-off box is close to NE-SW. Facing SW.

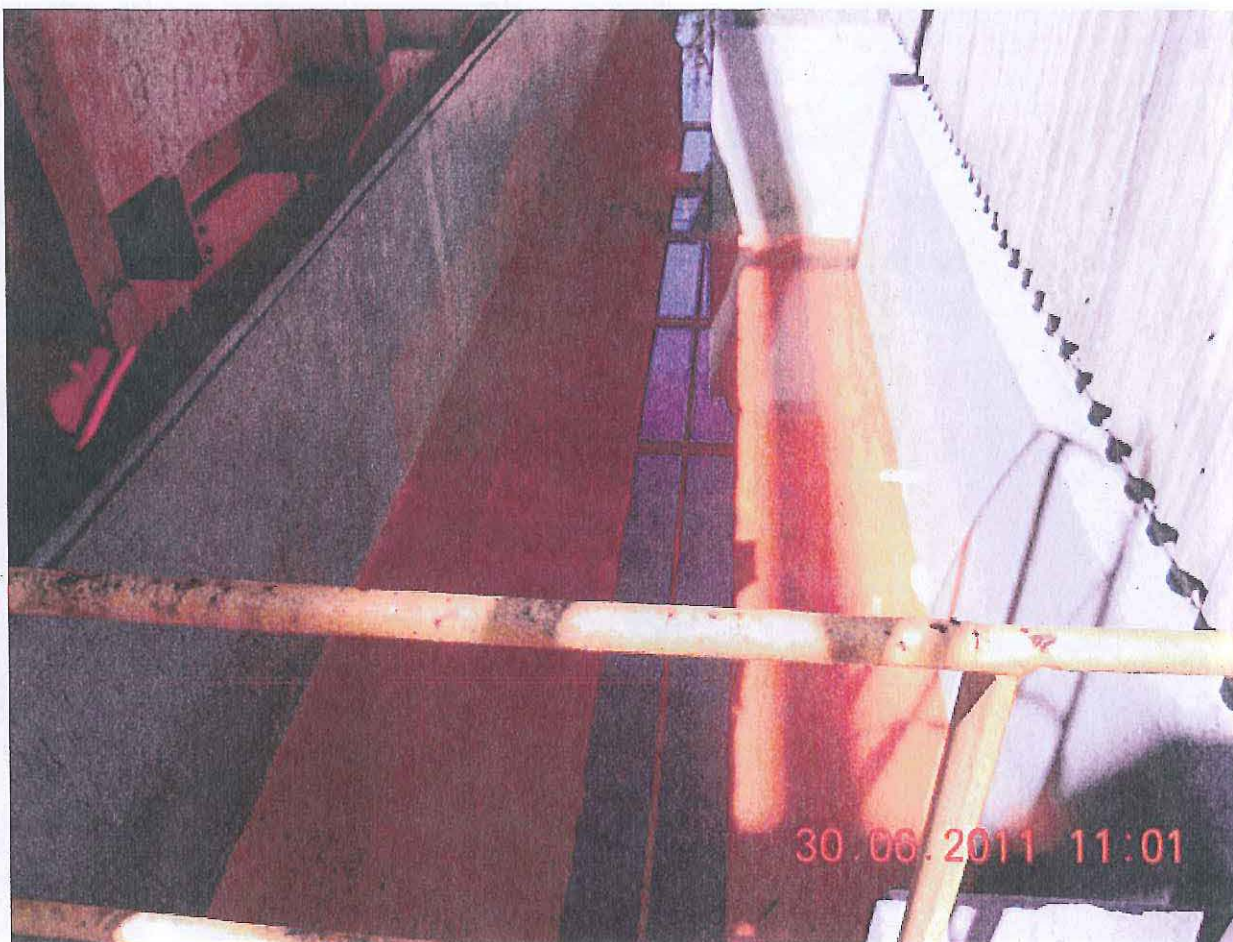
- Inspector Smith observed and photographed liquid in the secondary containment of the spent liquor tank (photograph 96).
- Inspector Smith observed and photographed that the liquid in the secondary containment of the spent pickle liquor tank had a rusty hue (photograph 97).
- Inspector Smith observed and photographed the pump for the spent pickle liquor tank (photograph 98).
- Inspector Smith observed and photographed a hose was flushing a trench that is located at or near the pump for the spent pickle liquor tank (photograph 99).

Facility: Arcelor Mittal, IND003913423
Location: 250 West US Highway 12, Burns Harbor, Indiana
Date: June 30, 2011, 11:01 a.m.
Photographer: Robert Dean Smith, LPG
Camera: Nikon Coolpix, 12.0 megapixels
Description: Photograph 96: Secondary containment for the spent pickle liquor tank. The water is rust in color. Facing W.

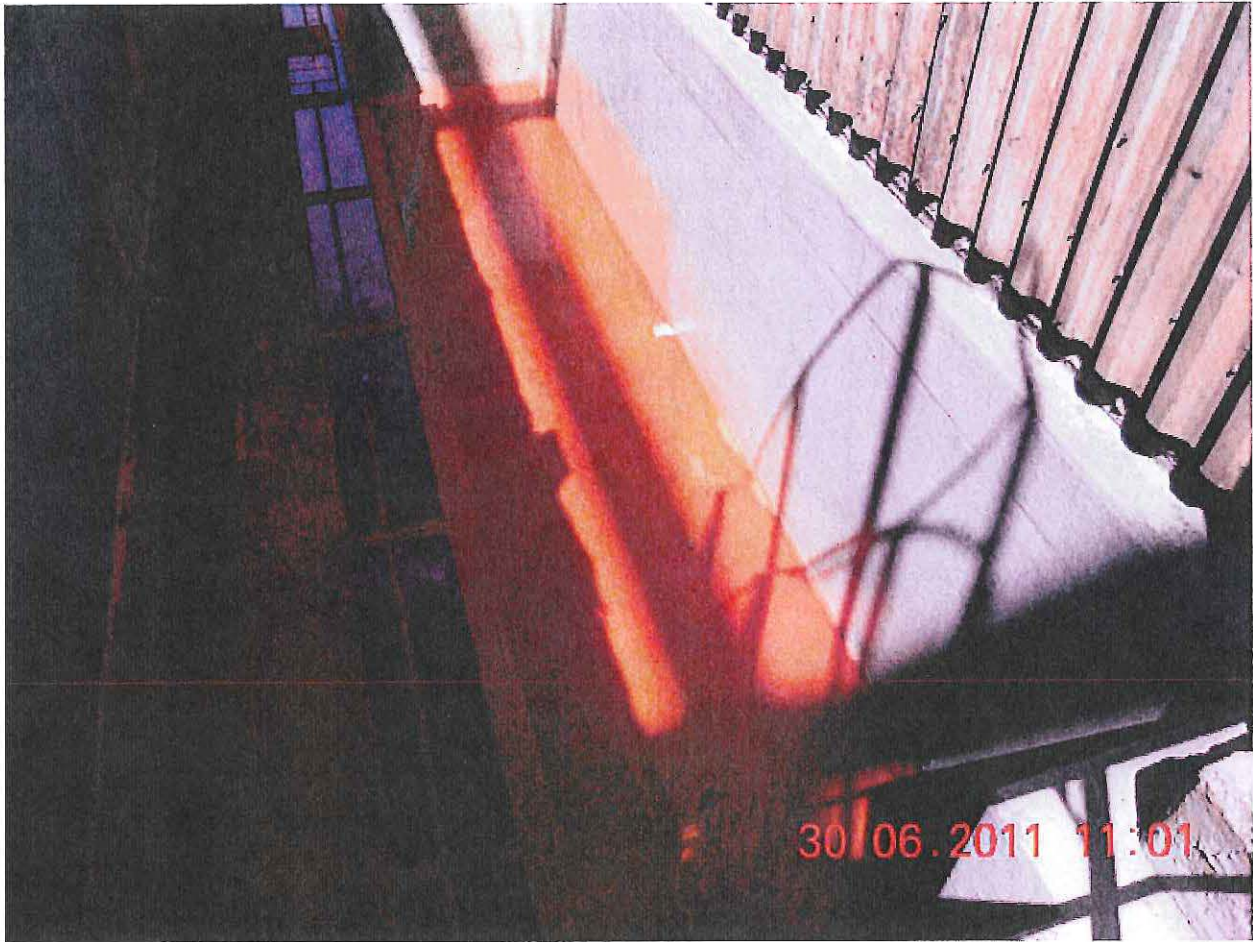
Facility: Arcelor Mittal, IND003913423
Location: 250 West US Highway 12, Burns Harbor, Indiana
Date: June 30, 2011, 11:01 a.m.
Photographer: Robert Dean Smith, LPG
Camera: Nikon Coolpix, 12.0 megapixels
Description: Photograph 97: Secondary containment for the spent liquor tank. Facing W.

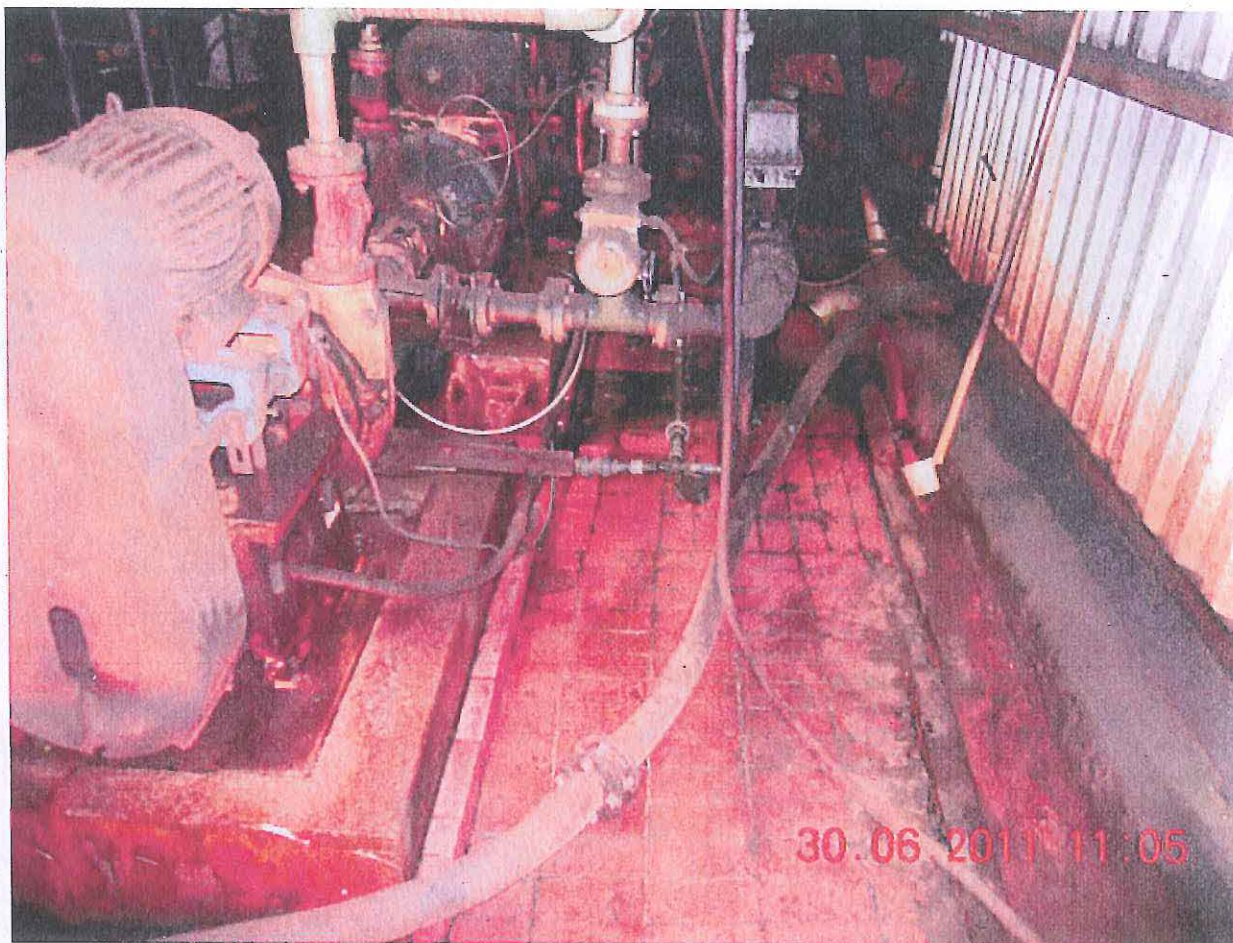
Facility: Arcelor Mittal, IND003913423
Location: 250 West US Highway 12, Burns Harbor, Indiana
Date: June 30, 2011 a.m.
Photographer: Robert Dean Smith, LPG
Camera: Nikon Coolpix, 12.0 megapixels
Description: Photograph 98: Pump for the spent pickle liquor tank.

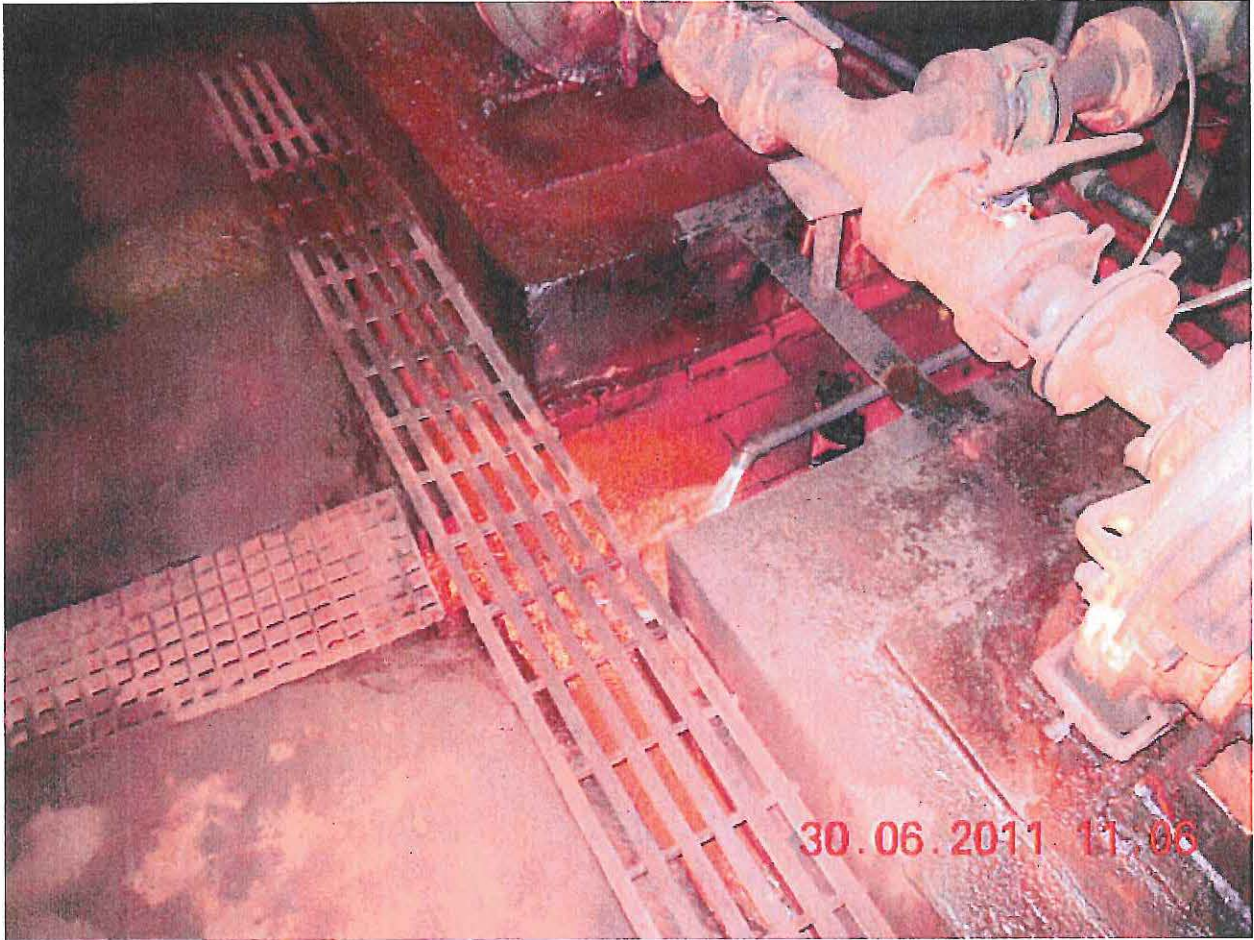
Facility: Arcelor Mittal, IND003913423
Location: 250 West US Highway 12, Burns Harbor, Indiana
Date: June 30, 2011 11:06 a.m.
Photographer: Robert Dean Smith, LPG
Camera: Nikon Coolpix, 12.0 megapixels
Description: Photograph 99: Trough adjacent to the spent pickle liquor tank pump. The trough is being flushed at the time of this photograph.
